# **Clayey Soils and Waste Brick Powder for Partial Cement**

**WN Replacement** Anuja Oke<sup>a,</sup>, Mumbi Kimani<sup>b</sup>, Esther Obonyo<sup>b,c</sup>, Mehrzad Zahabi<sup>c</sup>, Aly Said<sup>c</sup> <sup>a</sup>The University of Arizona, <sup>b</sup>Engineering Design, <sup>c</sup>Architectural Engineering The Pennsylvania State University, College of Engineering

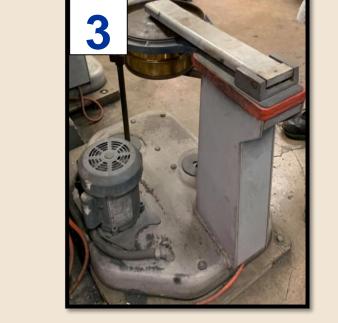
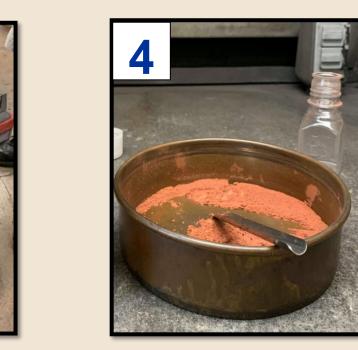
Brick was placed under a compression machine (1) and broken apart into pieces (2).

The pieces were ground into a fine powder (4) and sieved through a 75micron mesh using a sieve shaker (3).

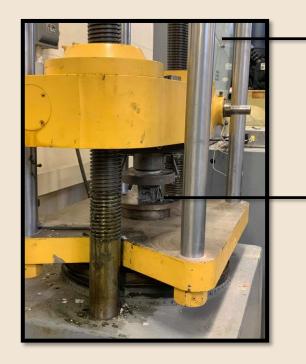
### **Figure 1.** Compressive Testing

### **Tinius Olsen Compression Machine**

Mortar Cube
